## Casereport

# Accidental Use of Plaster in a Dental Impression Leading to Metal Tray Retention: A Case Report

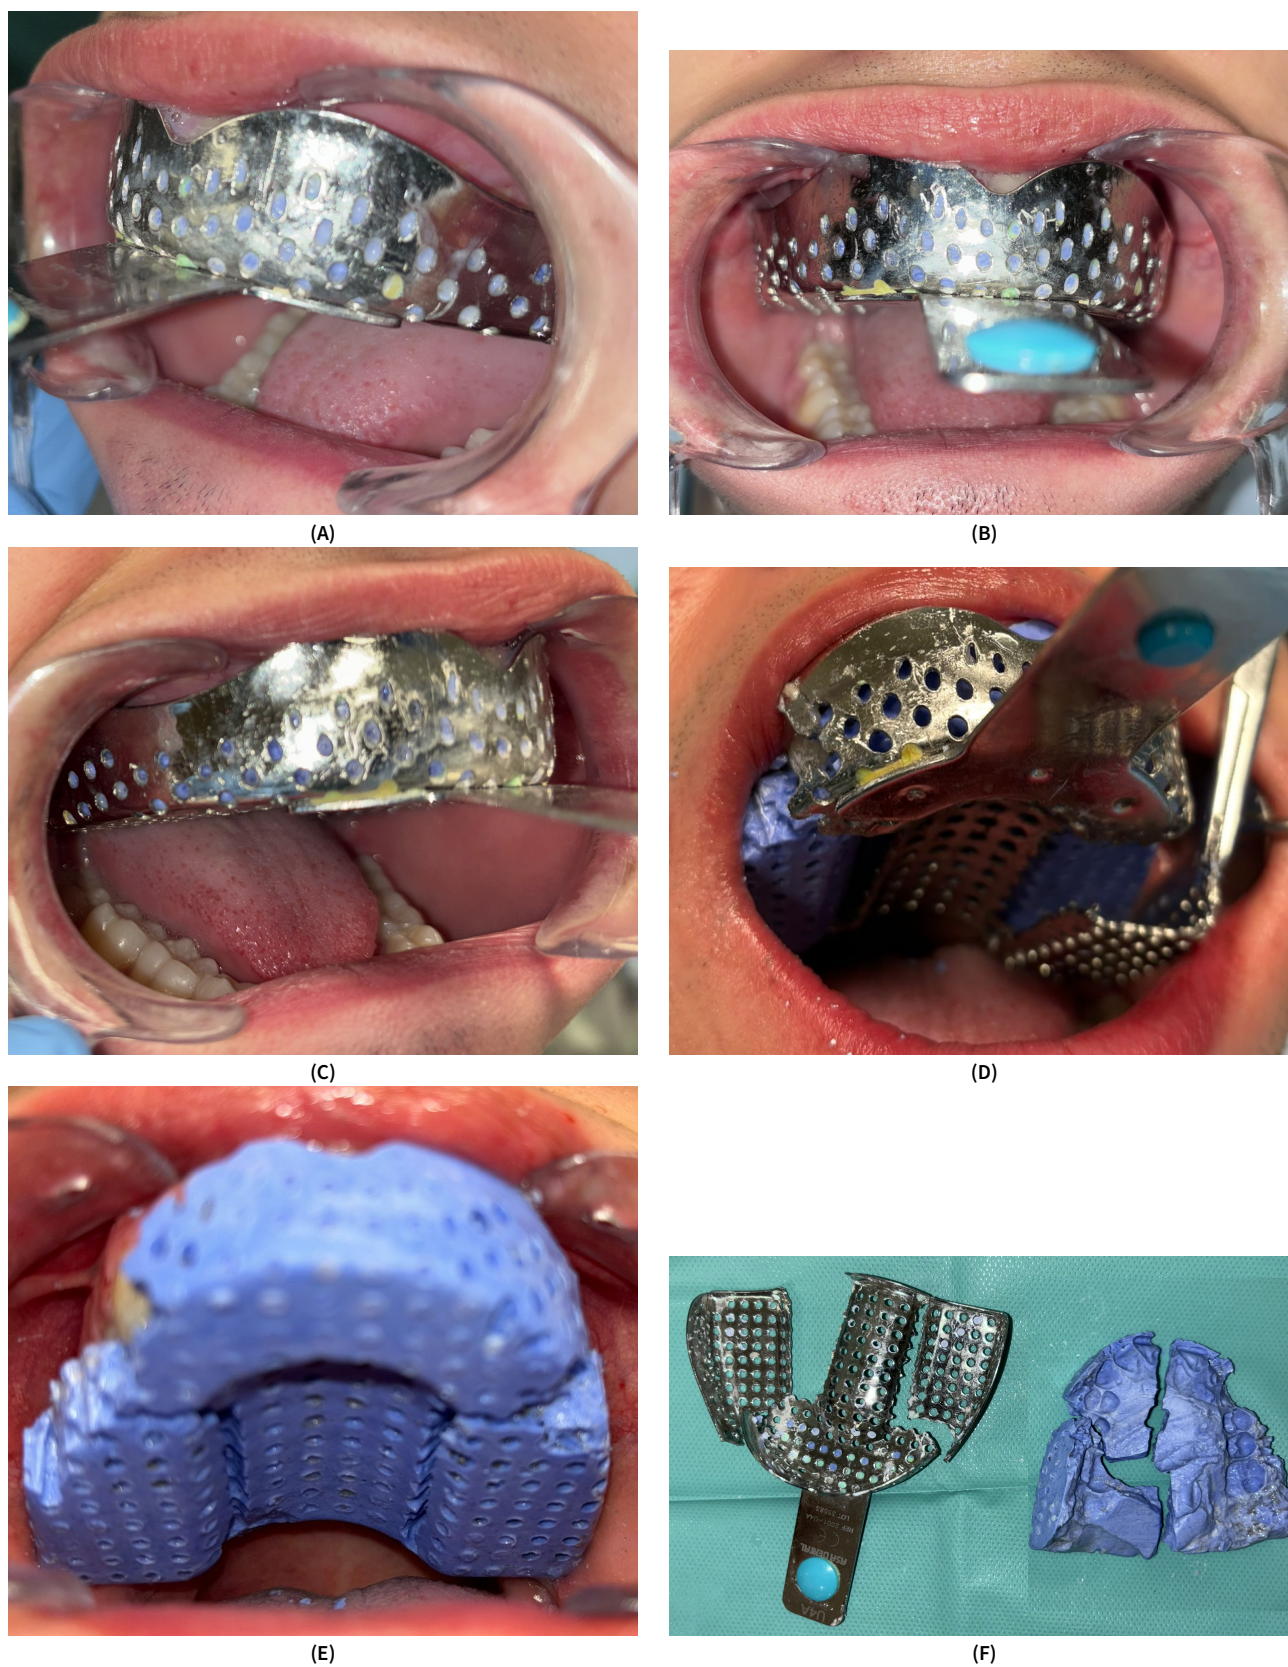
Examination revealed a standard, closed metal tray lodged in the maxilla and filled with hardened plaster (Figs. 1A, 1B, 1C). A small ulcer was noted on the palatal mucosa adjacent to the posterior border of the tray. No radiographic imaging (periapical, panoramic, or CBCT) had been obtained at presentation, as the tray remained in place within the patient's mouth. Temporomandibular joint assessment, including palpation, range of mandibular opening, and pain on function, was unremarkable.

To the authors' knowledge, this is the first reported case of impression-tray retention resulting from the inadvertent use of dental plaster. The central finding of this case is mechanical rather than chemical or thermal: a closed (non-perforated) tray filled with a rigid, non-elastic material becomes locked over the undercuts created by the crowns and interproximal contacts of the dental arch. Because set dental plaster, unlike alginate, has no elastic recovery, the tray-material complex cannot be withdrawn along its path of insertion without either fracturing the set material *in situ* or applying forces that risk damaging the teeth and supporting structures. This mechanism — rather than an exothermic reaction — best explains why the tray could not be removed intact and why removal required sectioning of the tray itself.

**Figure 1.** (A) Closed metal tray retained in the maxilla. (B,C) Intraoral views of the retained tray with hardened plaster. (D) Bilateral sectioning of the tray using a turbine with a diamond spherical bur. (E) Hardened plaster following removal of the sectioned tray. (F) Sectioned tray and removed plaster block ex vivo.

The procedure was performed without anaesthesia or analgesia, with the patient conscious throughout. The airway was protected by continuous suction for the duration of the procedure. The metal tray was sectioned bilaterally at paramedian points using a diamond turbine bur (Fig. 1D), with the handpiece's own water spray used for cooling, after which the hardened plaster was carefully removed with a handpiece and carbide bur (Fig. 1E, 1F).

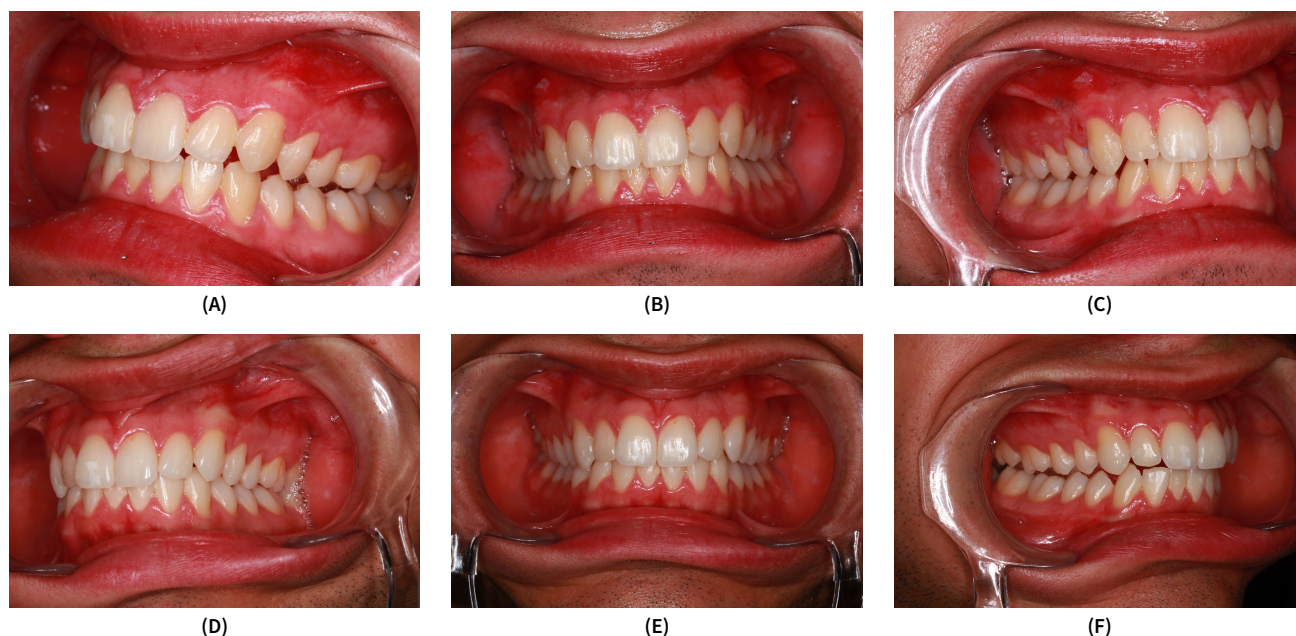
observed during or after the procedure. Sensitivity of the upper-arch teeth was preserved immediately after the procedure and at follow-up visits at one and five months (Fig. 2 shows the immediate and 5-month examinations), and temporomandibular joint findings remained unremarkable at both follow-up visits. The palatal ulcer was managed with surveillance alone, without antibiotic prophylaxis, and healed by secondary intention.

**Figure 2.** Assessment of upper-arch tooth sensitivity: panels A–C, immediately after the procedure; panels D–F, at the 5-month follow-up.
